TO: Minerals File  
FROM: Paul Baker, Reclamation Biologist *PBB*  
RE: Site Inspection, ECDC Environmental, LC, ECDC Clay Mine, M/015/062, Emery County, Utah

Date of Inspection: September 6, 2001  
Time of Inspection: 5:00 to 6:00 p.m.  
Participants: Tony Gallegos and Paul Baker, DOGM

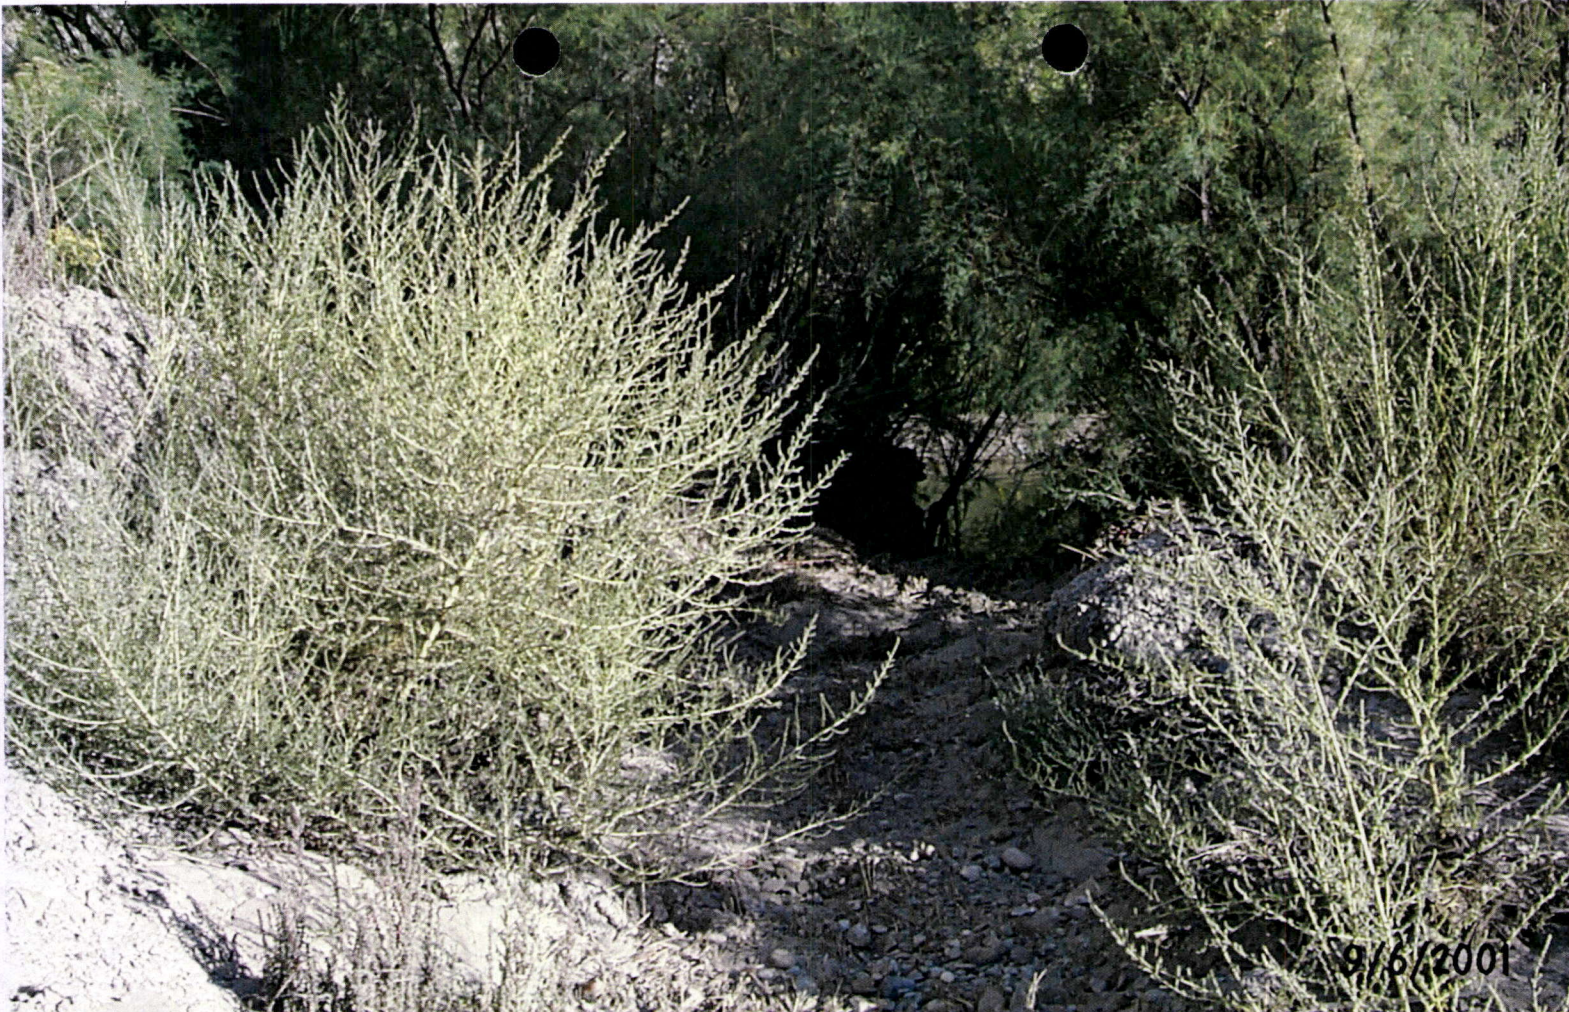
1

Northwest of the waste or spoil pile before the berm begins, there is a place where drainage enters the river. There was some straw and baling twine here indicating there had been straw bale dikes, but there were no stakes or other anchors. There was evidence that water had flowed through the area, and it was apparent it washed away the straw bales.

Photos of the site are attached to this report. The photos labeled 2 and 7 are overviews of the area. In photo 2, the pile in the center left is the area presumed to be a spoil or waste pile. In the foreground is an area with a low or non-existent berm. Photos 1, 3, 5, and 8 show where we found remnants of a straw bale dike. The other pictures are intended to show the proximity of the disturbance to the Price River.

The plan does not provide for straw bales in the area where we found them, and the drainage from this area is supposed to flow toward a drainage basin near the center of the disturbed area. Properly installed and well maintained straw bales would be acceptable as sediment control, but allowing these would entail modifying the plan which the operator has not proposed.

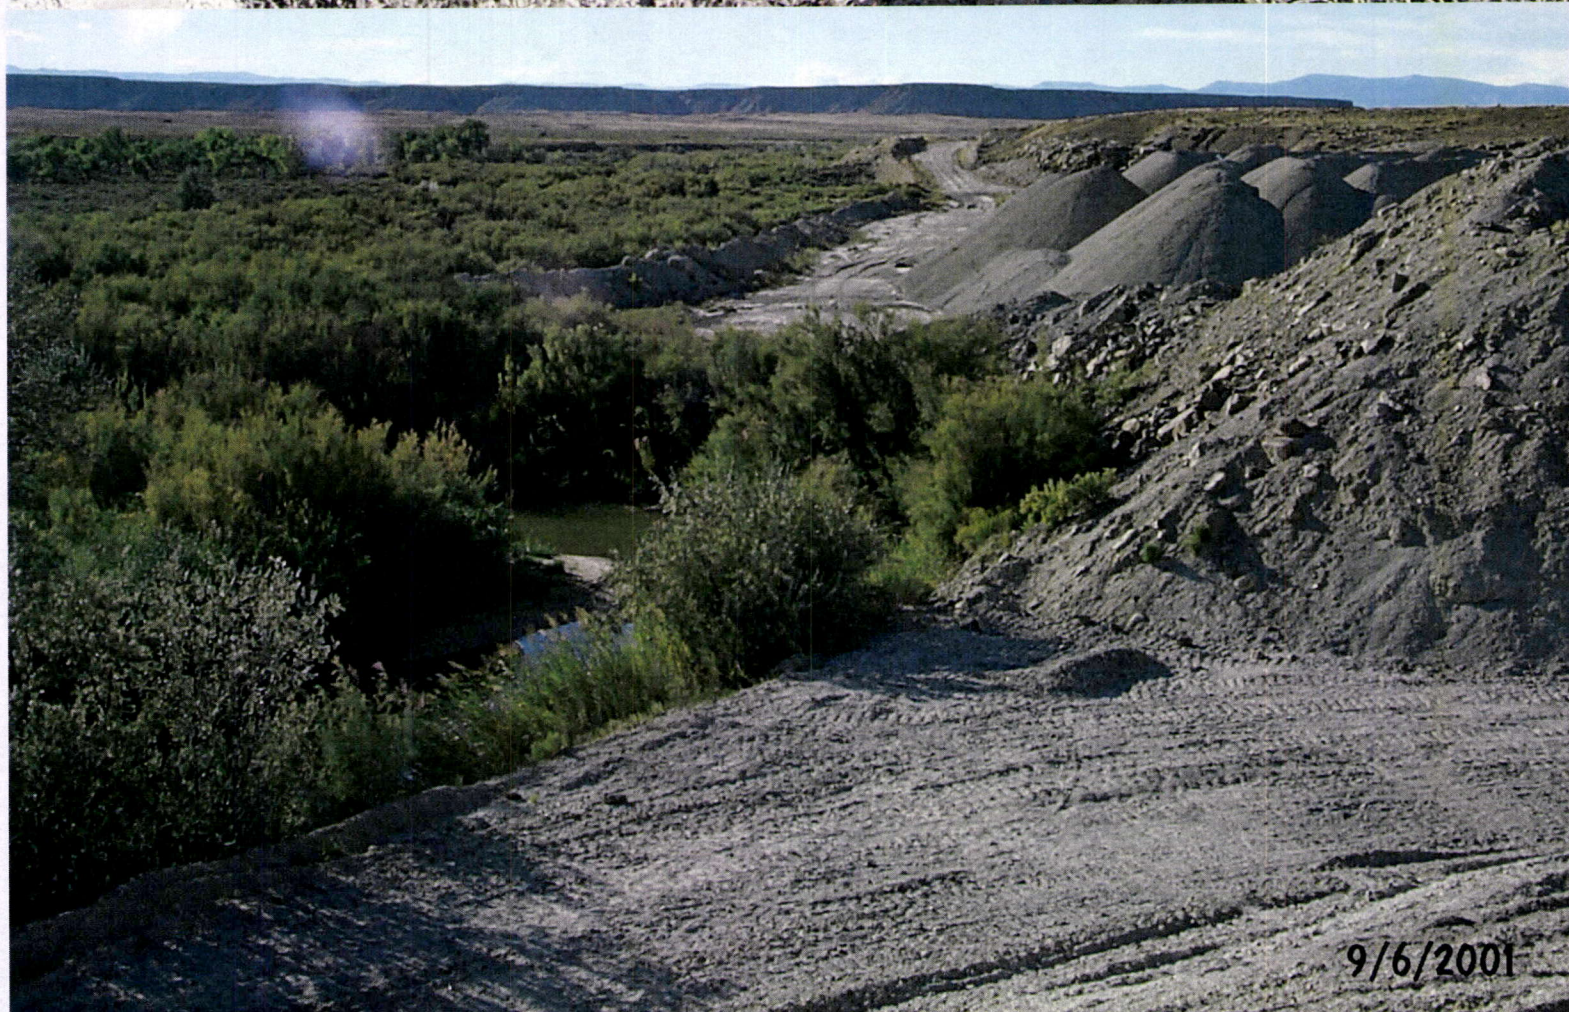
2

The earthen berm we found extends from near the bend in the river toward the northwest. From the bend toward the southeast, there is either no berm or only a short one that would be ineffective. The disturbance extends to within one or two feet of the bank of the Price

River and has covered most of the riparian vegetation in this area. Part of the disturbance includes what appears to be a spoil or waste pile, and there is evidence some of this material has sloughed or eroded into the river.

The site needs to be modified to match Exhibit VI in the plan. The spoil pile needs to be pulled back to allow room for an earthen berm 25 feet away from the river. Fill material placed near the river to the southeast of the pile also needs to be pulled back and a berm constructed to keep drainage from the mine from going into the river.

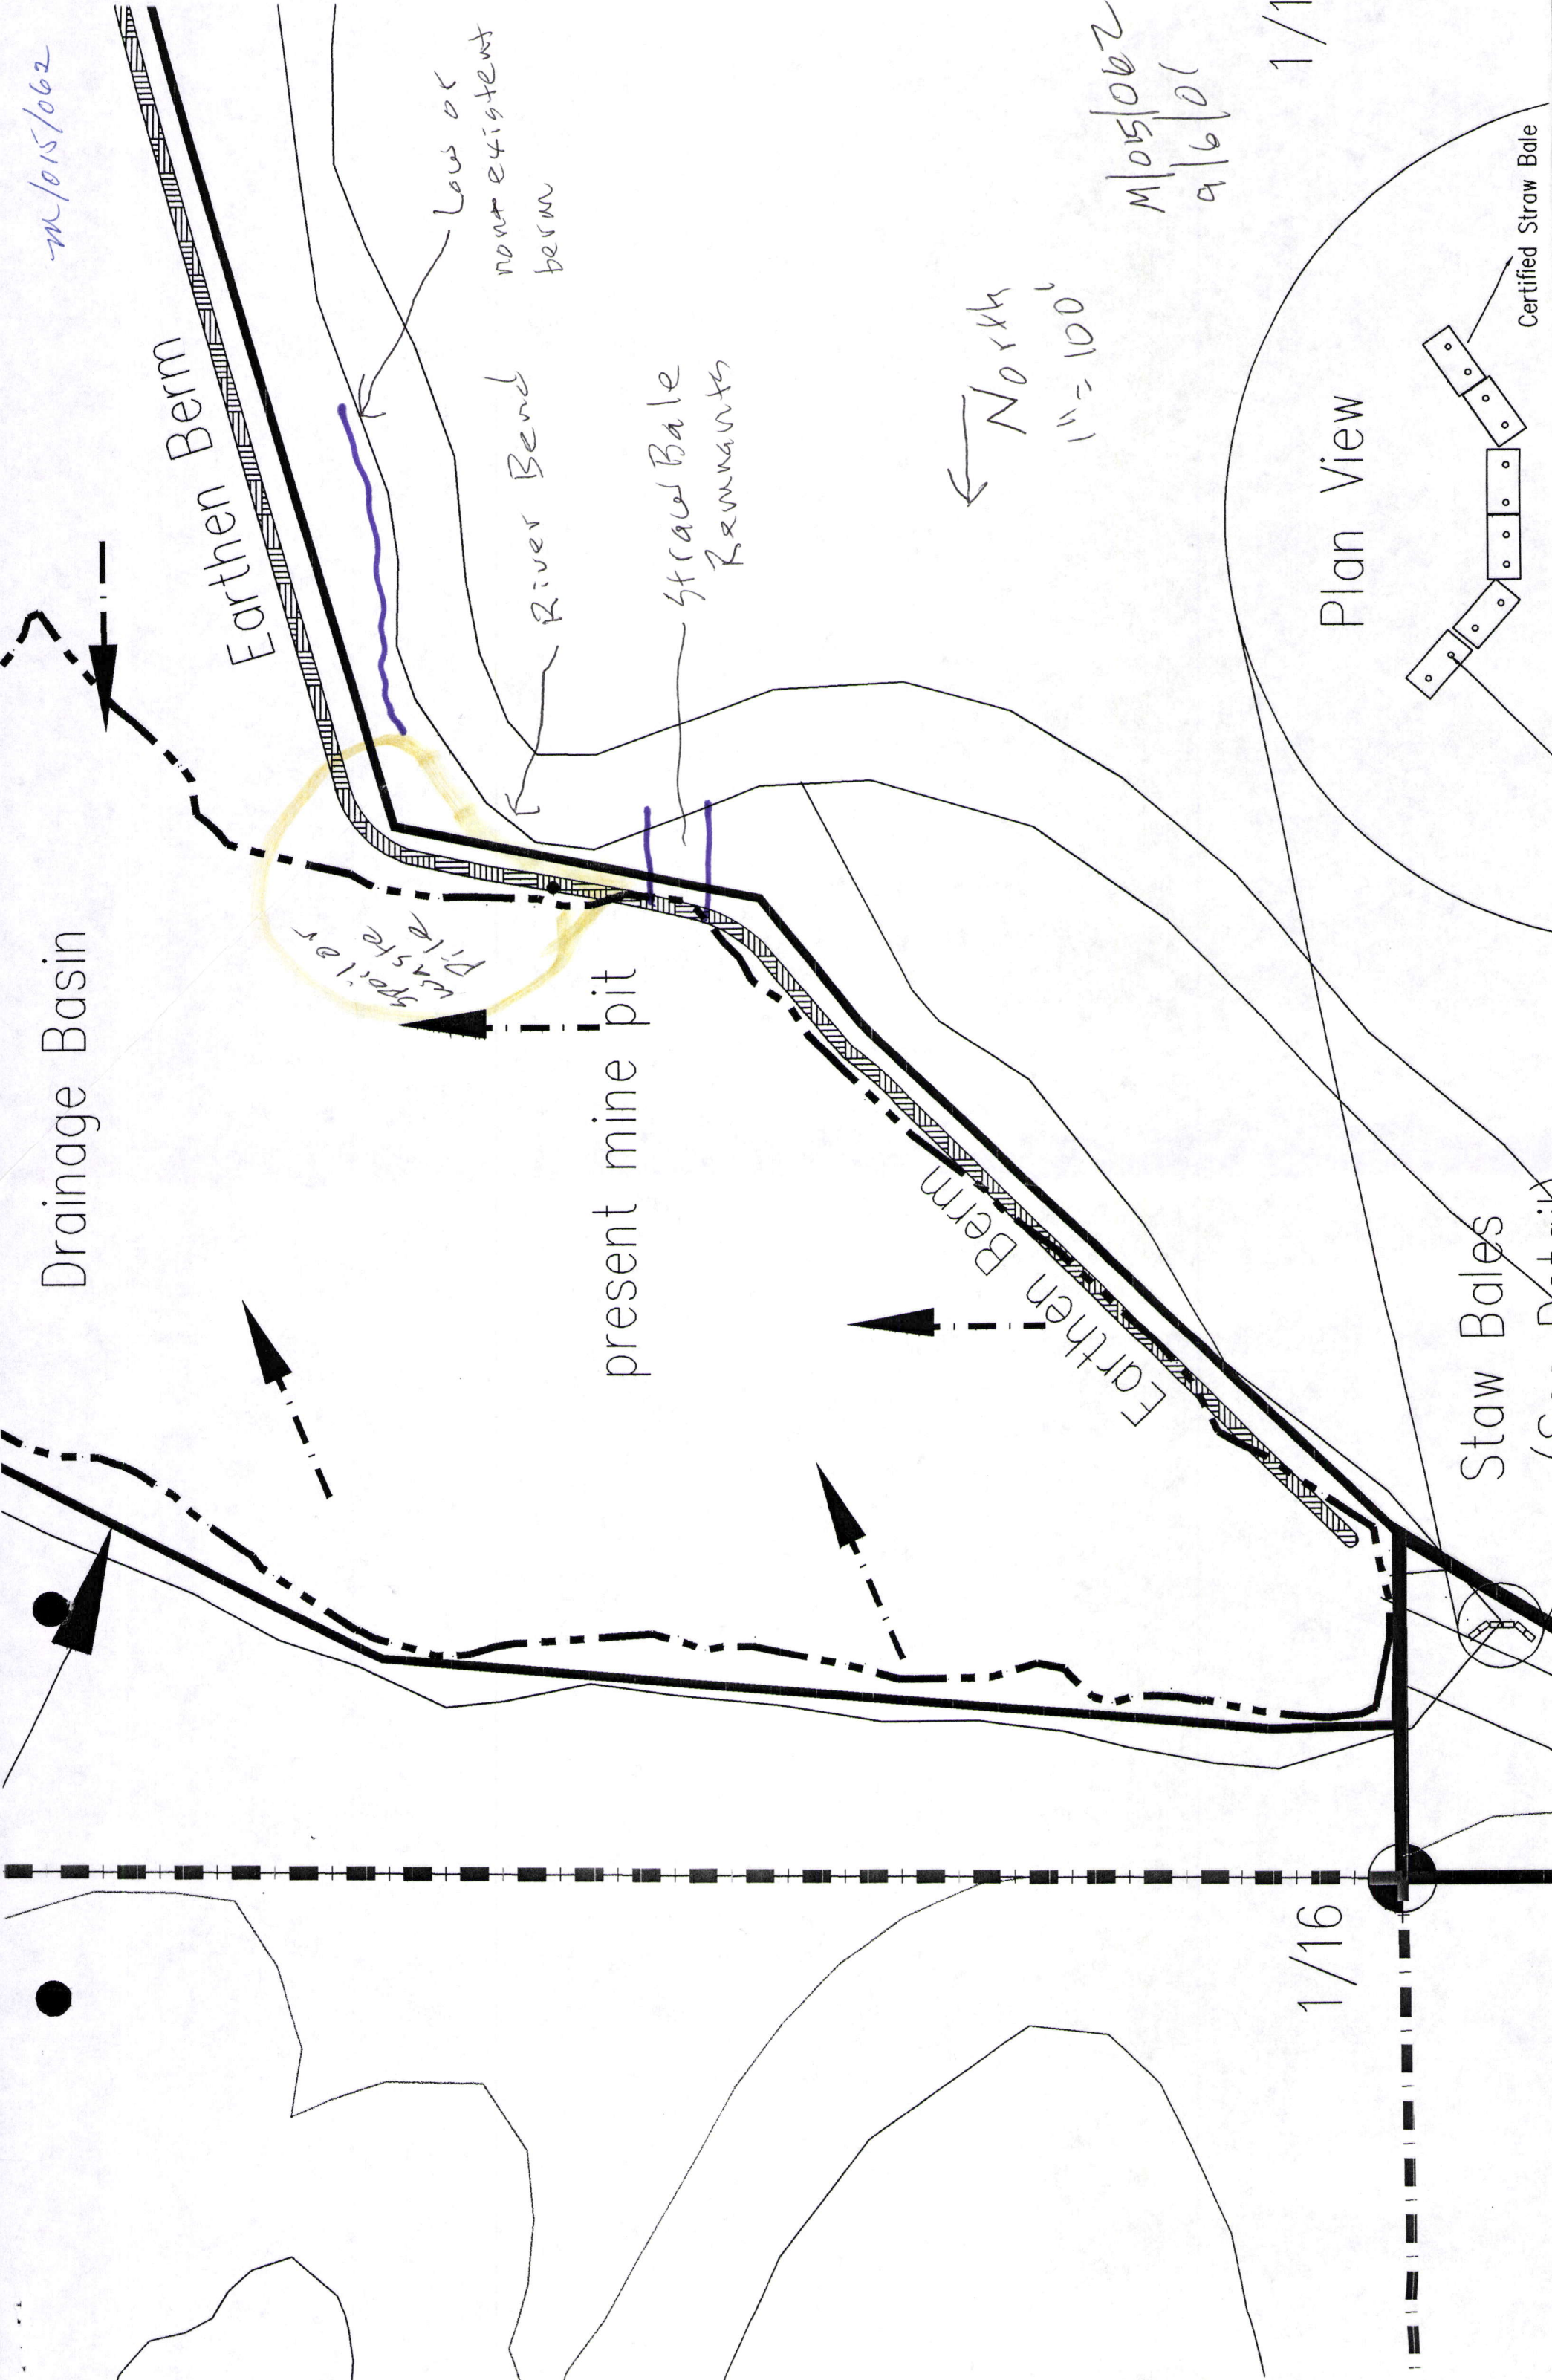
Exhibit VI of the operation plan in the file, dated March 15, 2000, shows an earthen berm along the Price River from the haul road to the end of the disturbance. According to this map, there is a sharp bend in the Price River where the berm is within 25 feet of the river, but otherwise, the berm should be no less than about 50 feet from the river. (See the attached copy of the map from the plan.)
